FINAL REPORT

EVALUATION OF COLD MIXES FOR WINTER POTHOLE REPAIR

Report No.	Report Date	No. Pages	Type Report:	Project No.:
VTRC 96-R9	November 1995	43	Final Report	9114-010-940
				Contract No.:

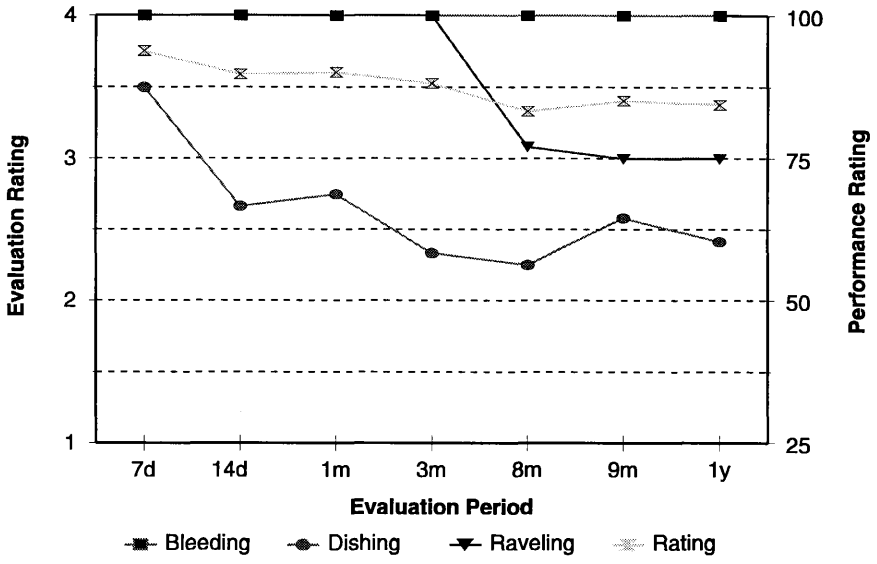
FIGURE 7. STYRELF STOCKPILE PATCH MIX, JULY 1994 TEST SECTION

Figure 7 shows a typical relationship between the performance rating of a product and its deterioration. The initial reduction in the performance rating was due to a combination of the

fair workability and the initial dishing due to densification under traffic loads. The onset of raveling in the form of loss of fines further reduced the performance rating at 8 months. The dishing rating at the end of the evaluation period corresponded to an average settlement of 6 mm. The complete survey results for the July 1994 and February 1995 test sections are presented in the Appendix.

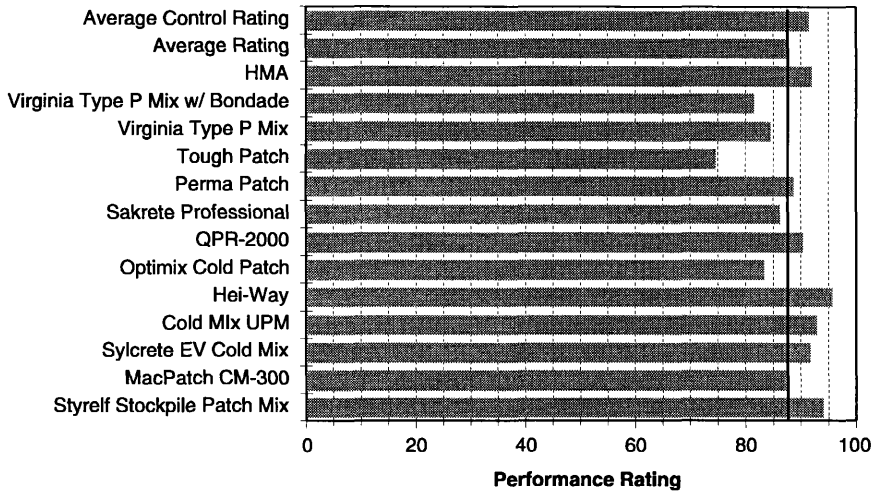
FIGURE 8. PERFORMANCE RATING AFTER 1 WEEK, JULY 1994 TEST SECTION

The average performance of the three replicates for the 7-day evaluation of the July 1994 test section is presented in Figure 8. The initial reductions reflect the workability ratings and the

early densification recorded as dishing. It should be noted that Tough Patch exhibited more than 12.5 mm of dishing during the 7-day evaluation. Due to the severity of the dishing, additional material was added at the request of VDOT officials to the Tough Patch replicates. Further densification was recorded after this addition.

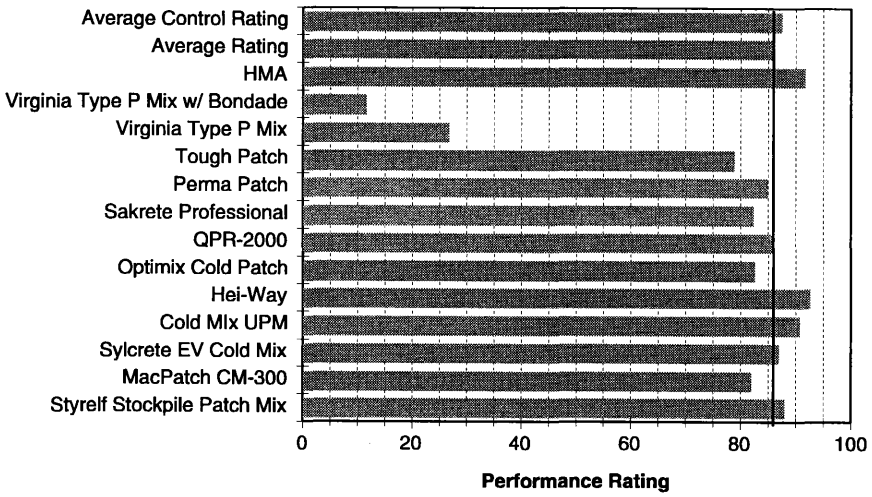
FIGURE 9. PERFORMANCE RATING AVERAGE, JULY 1994 TEST SECTION

An analysis of variance was performed in conjunction with Fisher's least significant difference (LSD) on the performance rating for each patch in the July 1994 test section using MINITAB Statistical Software. These procedures compare the rankings of the average performance ratings (at the end of 1 year for each replicate). The analysis showed that all of the

proprietary products performed significantly better than the Virginia Type P mix (with and without Bondade) at the 95% confidence level. Significant differences existed between some of the proprietary materials. From this analysis, HEI-WAY and Sylcrete were selected as candidate products for the Special Provision for High Quality Cold Patching Materials. The comparisons for HMA, UPM, HEI-WAY, Sylcrete, and Optimix are presented in Table 5. HEI-WAY performed statistically the same as HMA and UPM, which had the highest overall and cold-mix ratings, respectively, after 1 year. Though Sylcrete performed worse than HMA, it performed as well as the two best cold-mix products, HEI-WAY and UPM. The next highest ranked product,

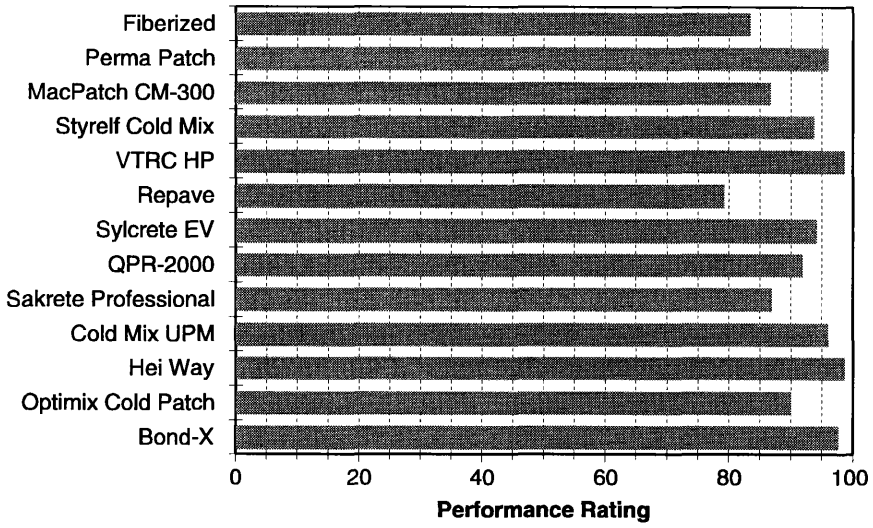
FIGURE 11. PERFORMANCE RATINGS AVERAGE, FEBRUARY 1995 TEST SECTION

All of the materials placed in the February 1995 test section (with the exception of RePAVE) showed significantly less dishing than those placed in the July 1994 section. This was probably because of the reduced pothole depth.

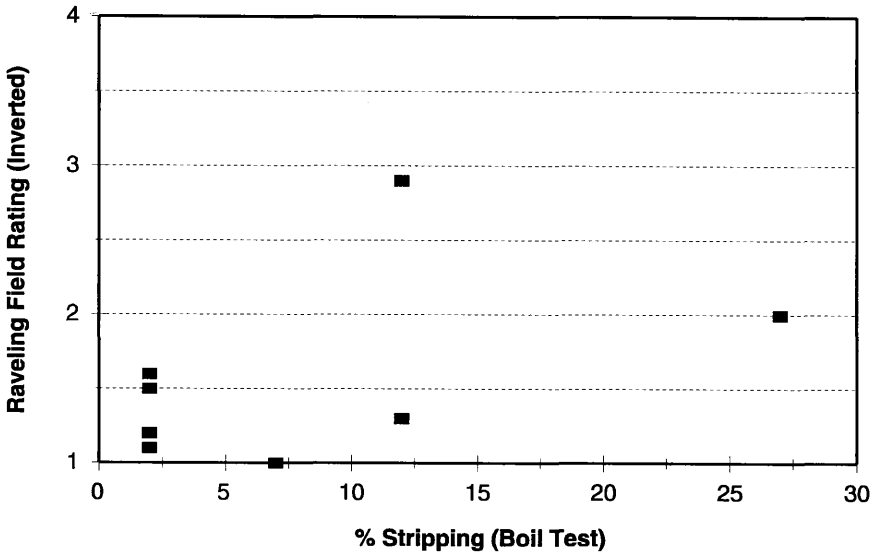
FIGURE 13. STRIPPING VERSUS RAVELING AT 1 YEAR

was not included since results were unavailable for the boil test. A simple linear regression was performed using percentage stripped as the predictor variable for the observed raveling rating using Quattro Pro. The predictor variable is the independent, or x, variable, and percentage stripped is the dependent, or y, variable. Quattro Pro calculates both the best-fit linear equation ($y = ax + b$) and the coefficient of determination (R^2) that represents the degree of correlation between the variables or the fraction of variation in y explained by the fitted equation. Quattro Pro also calculates the standard error of the y estimate (s). The $R^2 = 0.20$ indicates a relatively poor correlation, which may be expected considering the small spread of the data.

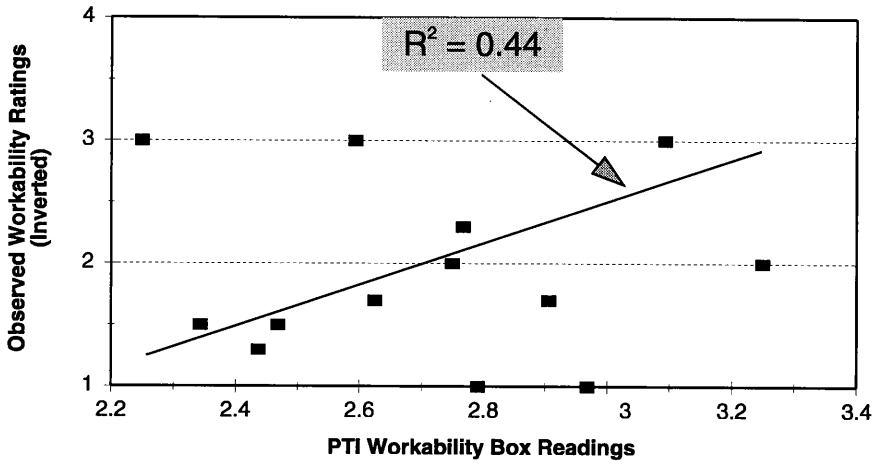
FIGURE 14. PTI WORKABILITY VERSUS FIELD WORKABILITY

All of the mixes passed the PTI workability test (Penetration No. < 4.0). Six of the materials fell in the marginal range (3 < Penetration No. < 4). A scatter plot of PTI workability penetrometer readings versus inverted (1 = good workability and 3 = poor workability) observed workability ratings is presented in Figure 14. A simple linear regression was performed using the PTI penetrometer readings as the predictor variables for the observed field workability. The R^2 value was 5.4%, and the number of observations *(n)* was 14. The scatter plot seemed to indicate a better correlation. Two points were considered as potential outliers. The Virginia Type P mix showed good workability in the field, but the sample tested in the laboratory suffered from draindown and appeared to have partially cured. Sakrete had the worst values for field

workability, but once the material was sufficiently broken up to test it in the workability box, it was fairly noncohesive and crumbled at low temperatures, providing low penetrometer readings. With these points removed, the regression was rerun with an observed R^2 = 44.1%, standard error of the estimate *(s)* = 0.53, and n = 12. This indicates the test may be used to estimate the workability of the material.
